Brush Seal Performance and Durability Issues Based on T-700 Engine Test Results

R.C. Hendricks
Lewis Research Center
Cleveland, Ohio

March 1994

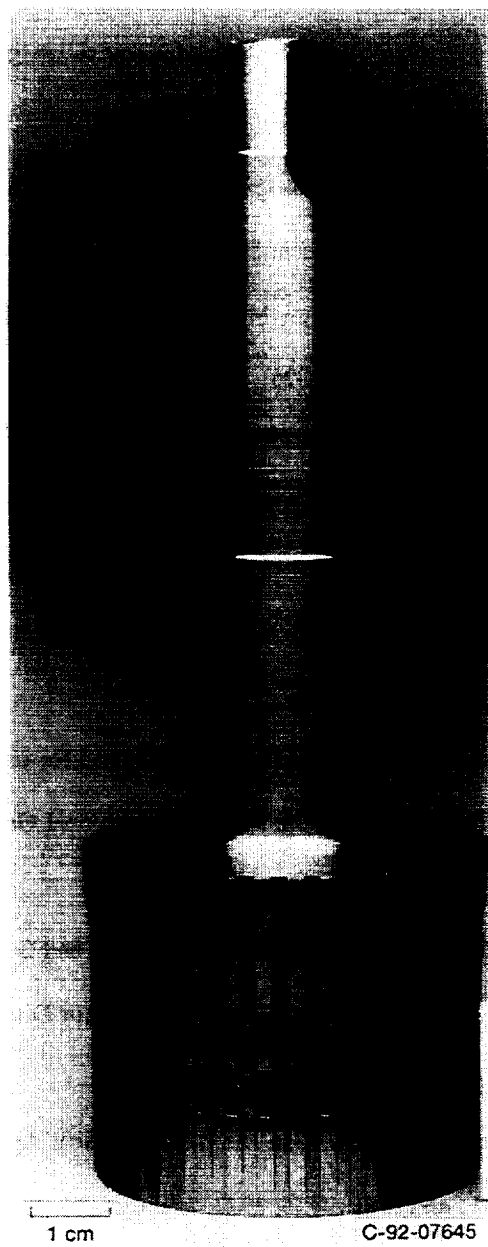
Figure 1.—Geometry of tapered, 40-tooth rotor.

In a rather harsh test at low surface speeds, brush seals were subjected to hard rubs by engaging the bristles into a 40-gear-tooth rotor (Fig. 1). The bristles withstood over 1×10^9 cycles without pullout, fracture, or massive debris generation. Under conditions of severe rotor-stator interface damage, the seal leakage performance degraded some 30 percent, but the brush seal did not fail (Hendricks et al. [1993a]).

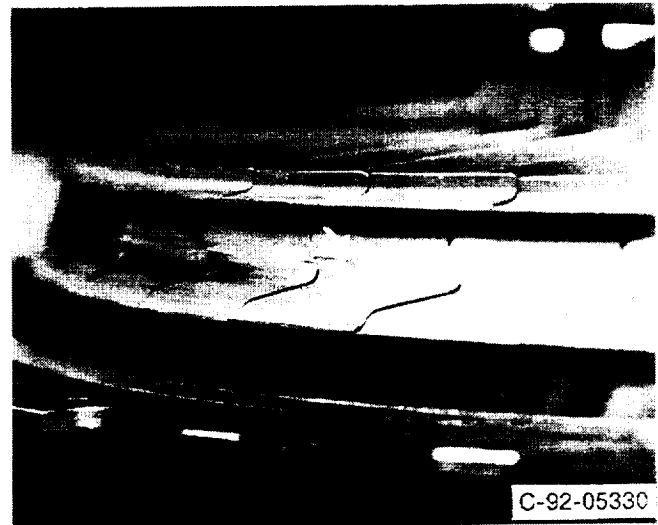
Figure 10.—Fourth-stage turbine after testing, showing polishing of leading edges.

1. Properly designed brush seals have sufficient integrity to withstand highly irregular surface operations at speeds to 335 m/s (1100 ft/s) and shroud temperatures to 620 °C (1150 °F) with a noncentered turbine orbit during steady and cyclic loading.
2. Upon initial startup, bristle debris can be expected when installations are blind and surfaces are disjointed (e.g., shrouded blades).
3. Brush wear was estimated to be line to line with the maximum rotor orbit.
4. Installed torques can be high, but rub-in torques are low. In this case rotor reversals are not permitted.
5. The sacrificial elements were the Haynes 25 brush bristles; the René 80 turbine blades evidenced minor polishing.

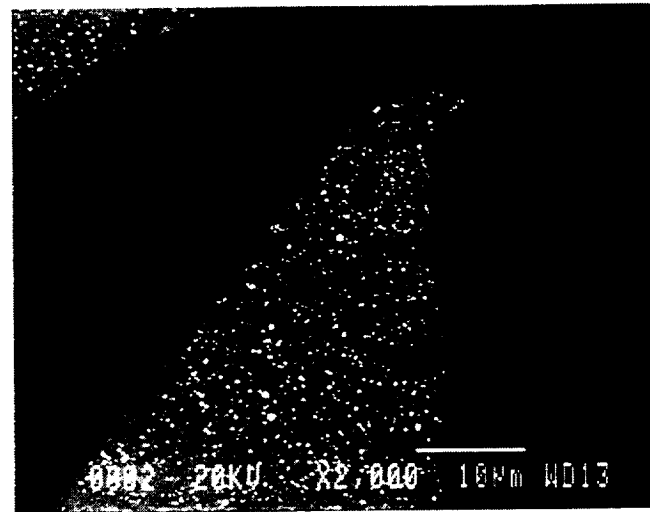
Figure 12.—Post-test analysis of bristles cut from brush seal, showing irregular tips.

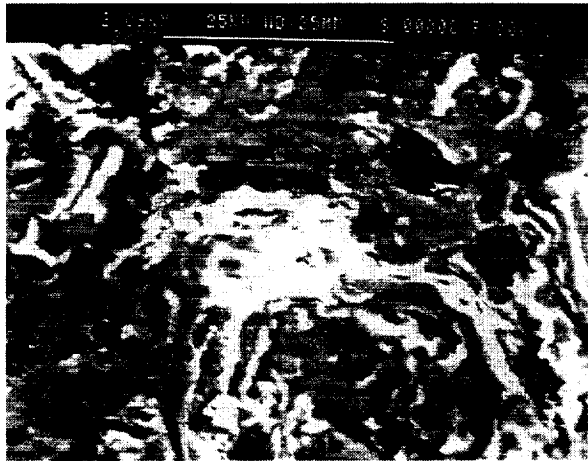
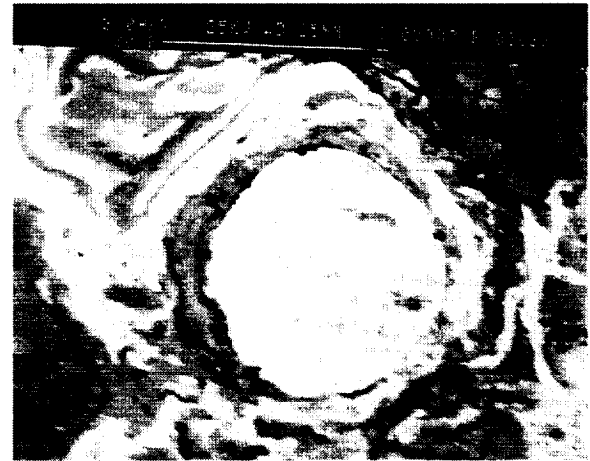
Figure 18.—SEM peaks associated with chromium-carbide-coated rub runner.

(a) Light area in coating matrix between bands.

(b) Light area in upstream (lower) wear band.

(c) Light area in downstream (upper) wear band.

The geometries of the seal, rub runner, and engine seal package were well defined. The nominally 0.13-mm (0.005-in.), 8-rms, rub-runner coating was chromium carbide, a D-gun-sprayed mixture of Cr_3C_2 and Cr_7C_3 with a nickel chromium binder [65(92Cr-8C) + 35(80Ni-20Cr)]. The bristles were Haynes 25 alloy. From testing experience, it was assumed that 40 percent of the pressure drop would occur across the first brush and 60 percent across the second brush, implying stiffer bristles and greater wear on the second brush. This anticipated result is shown in Figs. 15 and 16. Figure 15 illustrates the nominal rub surface wear; and Fig. 16, the wear associated with an assumed hard start or dynamic excursion. Further metallographic analysis of the brush bristle wear bands and the matrix material (Fig. 17) showed little or no evidence of material loss or transfer (Fig. 18). The bristle tips exhibited some shear smearing and evidence of some oxidation but were otherwise clean (Fig. 19).

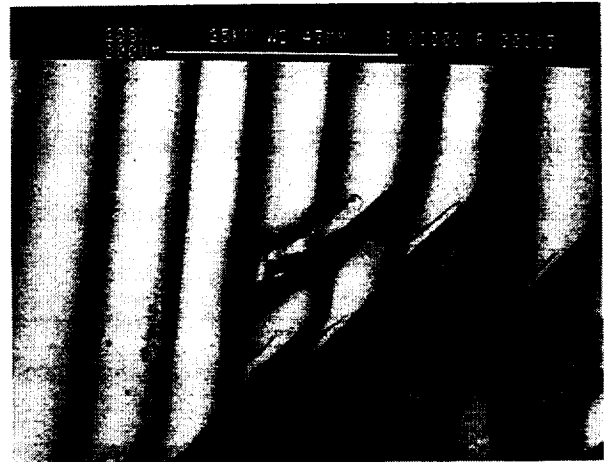
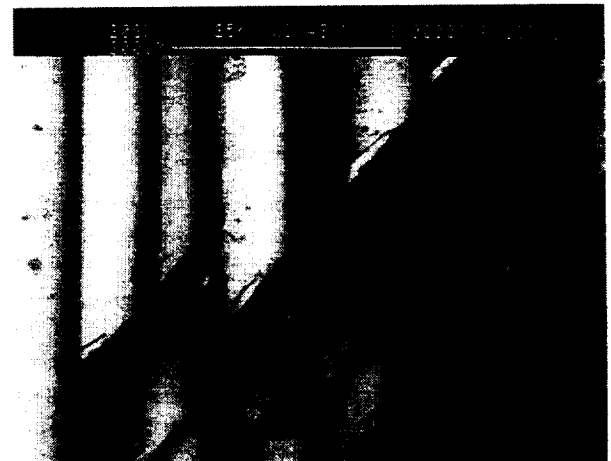
Figure 19.—Closeup views of bristles (compressor discharge seal).
